METALS HANDBOOK

VOL. 9
FRACTOGRAPHY AND ATLAS OF FRACTOGRAPHY

8th EDITION

Fractography and Atlas of Fractographs

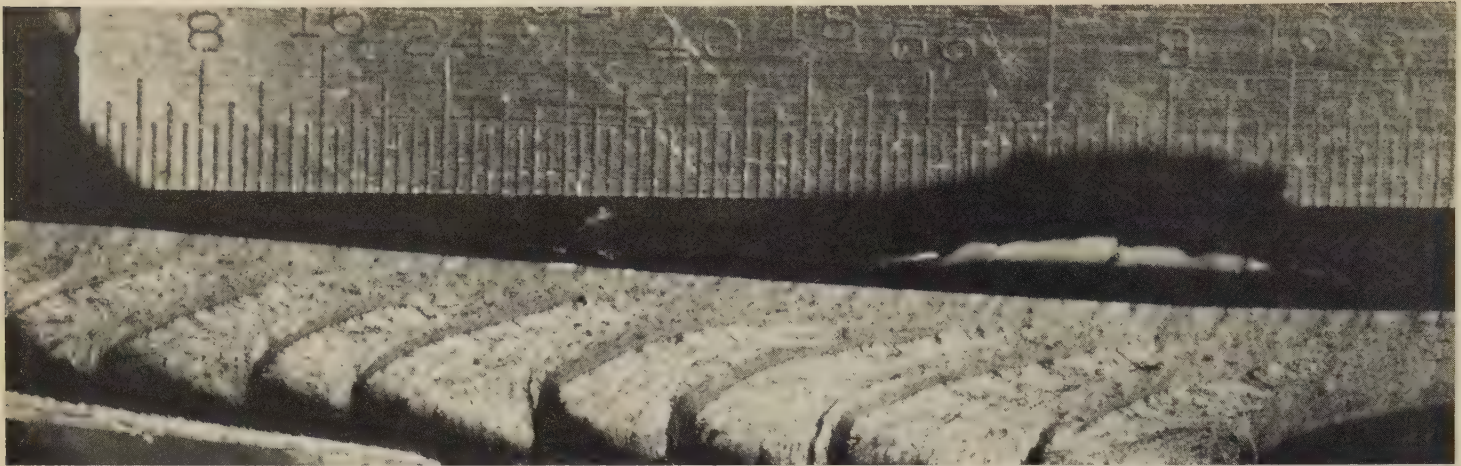
Light fractograph

4272 Fracture surface showing an example of "hackle marks", which consistently point in the direction of fracture propagation. By tracing such marks backward, it is possible to locate their common origin, which is the point of fracture initiation. Here, the origin is at the right, and fracture proceeded from right to left. Hackle marks occur during fast fracture.

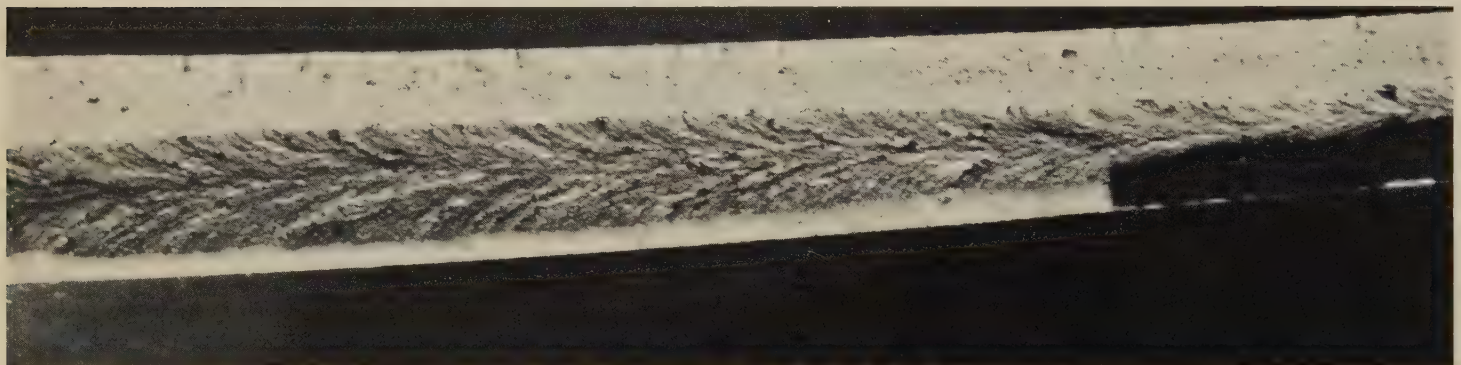
Light fractograph

4273 Fracture surface showing an example of "chevron marks", which commonly are seen in overload fast fractures. Chevron marks consistently point toward the origin of fracture. Here, the origin is at the right, and the direction of fracture propagation was from right to left.

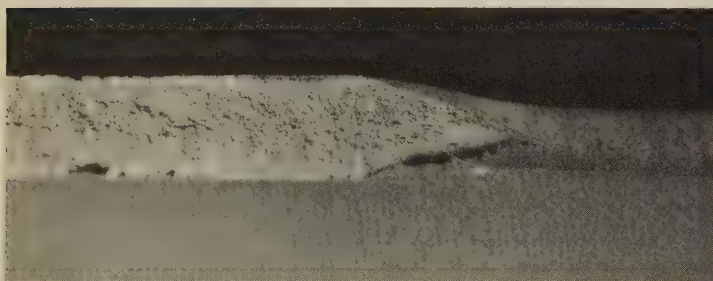
Light fractograph

4274 Fracture surface showing a localized zone of plane-strain fracture (at left), the configuration of which indicates that fracture propagated from left to right in this view.

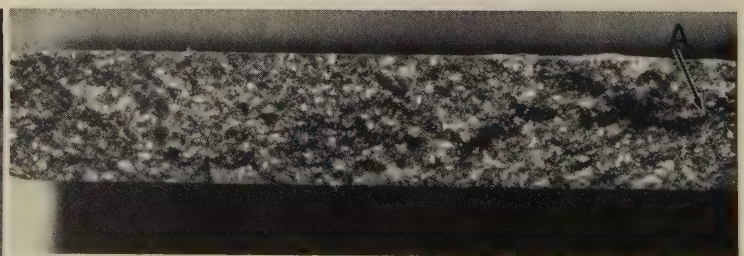
Light fractograph

4275 Fracture surface of a 0.13-in.-thick sheet of annealed Armco iron broken in shear overload at -196°C (-321°F). Tensile strength, 276 MPa (40 ksi). A flat, granular surface. Area at A is shown at higher magnification in 4276 (facing page).

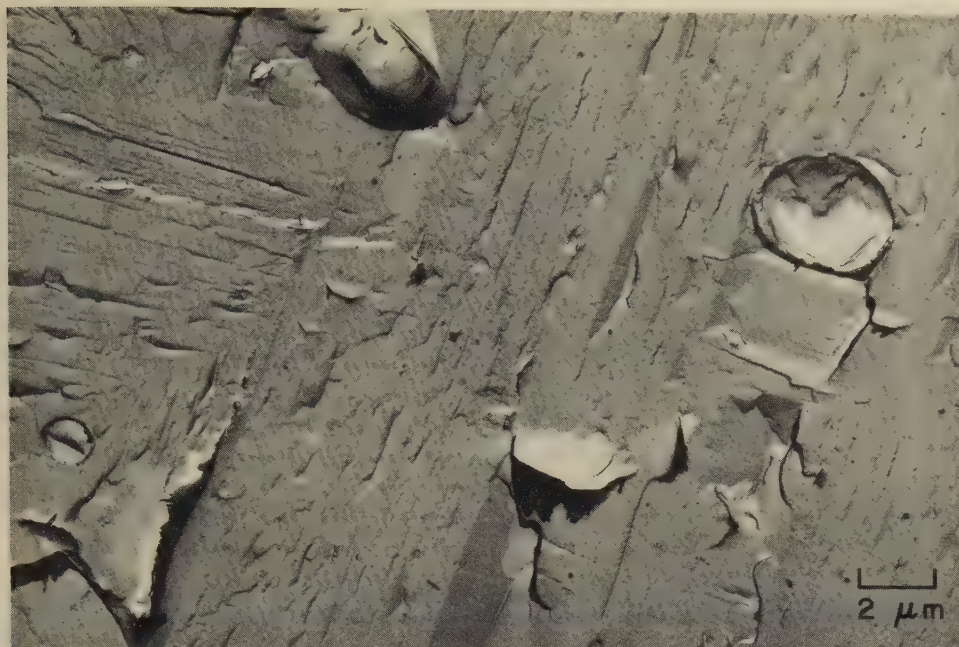
TEM fractograph (p-c replica)

4276 A TEM replica of area A of the surface of the low-temperature shear-overload fracture in Armco iron shown in 4275. This surface exhibits a pattern that is characteristic of cleavage fracture. The local direction of crack propagation was from top to bottom, as suggested by the angle of the tongue below center, which was formed by a local fracture along a twin-to-matrix interface.

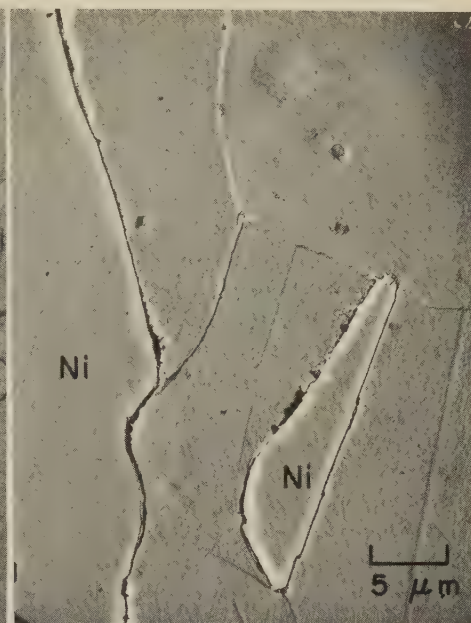
TEM micrograph (p-c replica)

4277 A TEM replica of a polished and etched section through a Charpy impact specimen of Armco iron broken at -196°C (-321°F). Fracture surface, shown in profile (at left, protected by nickel plate), was produced by cleavage. See also 4278.

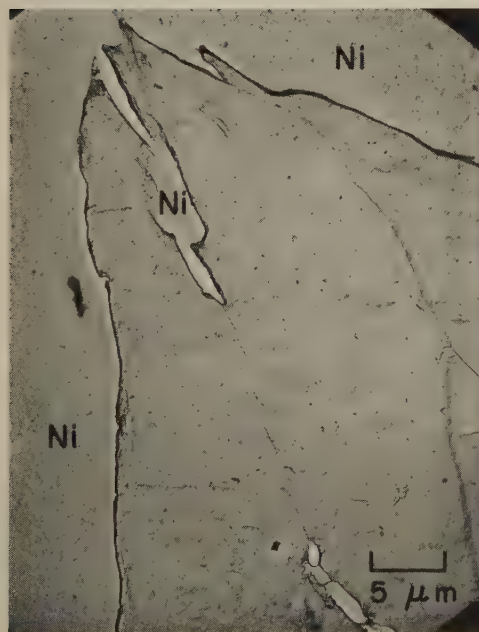
TEM micrograph (p-c replica)

4278 A TEM replica of a polished and etched section through a Charpy impact specimen of the same Armco iron as in 4277 but broken at room temperature. Visible at left and at top is a profile of the fracture surface (protected by nickel plate), showing some deformation. See also 4279.

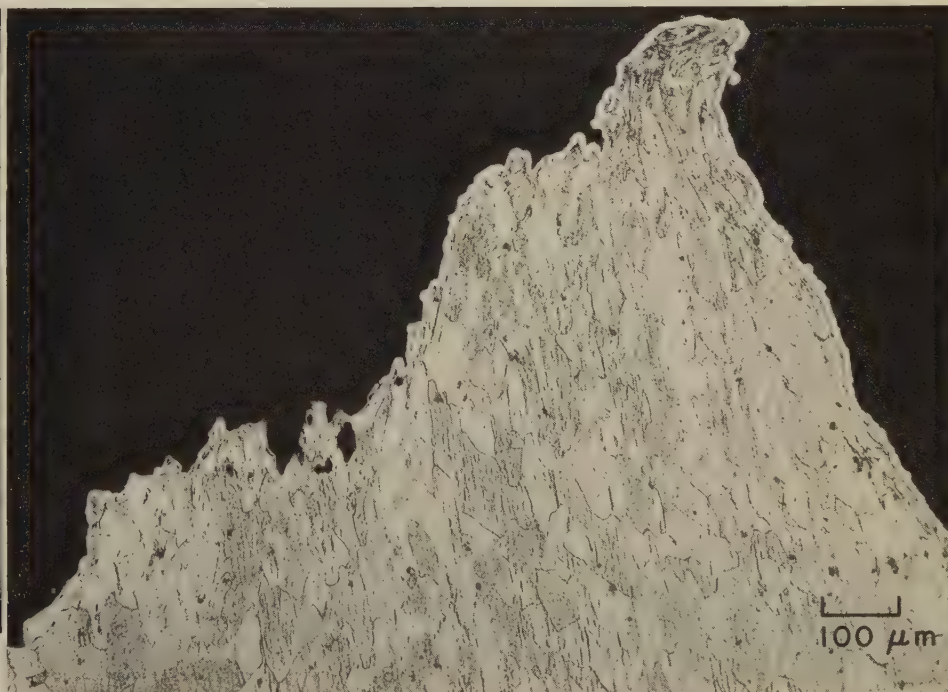
Light micrograph (etchant: nital)

4279 A polished and etched section through the same Charpy impact specimen of Armco iron as shown in micrograph 4278 (at left), which was broken at room temperature. Note that in the region of final fracture (at top right) there has been decided elongation of the grains.

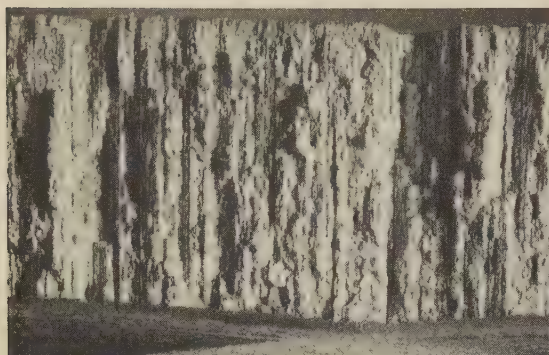
Light fractograph 6×
4280 Surface of an impact fracture in a notched specimen of wrought iron. Here, the longitudinal stringers of slag in the material are parallel to the direction of fracture, which gives the surface this typically "woody" appearance. Compare with fractograph 4281, at right.

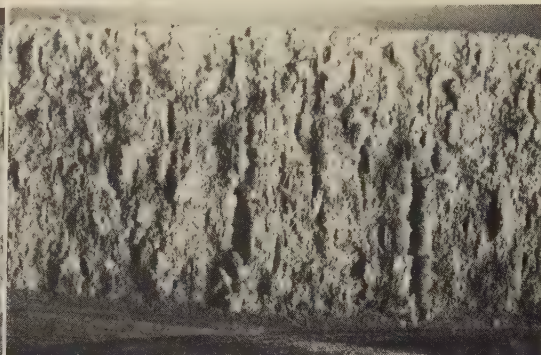
Light fractograph 6×
4281 A companion notch-impact fracture to the one shown in fractograph 4280, but here the longitudinal stringers of slag are normal to the fracture surface. Individual particles of slag are not readily visible at this magnification, but they cause the speckled appearance.

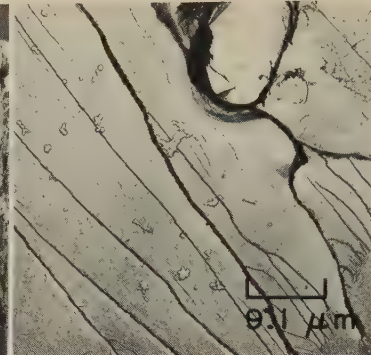
TEM fractograph (p-c replica) 1100×
4282 Charpy impact fracture in wrought iron broken at -59 C (-75 F), showing a cleavage surface normal to slag stringers. Portion of a slag particle is at top. See 4283-4285.

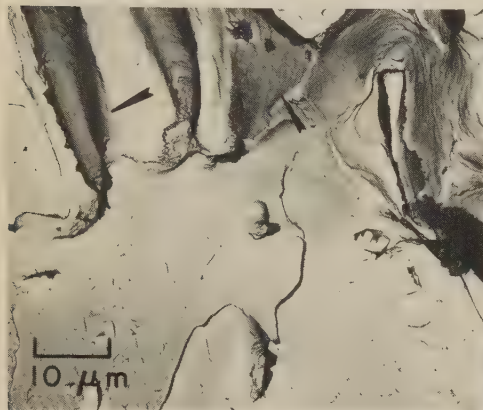
TEM fractograph (p-c replica) 1000×
4283 Surface of a Charpy impact fracture in a second specimen of the same wrought iron as in fractograph 4282, but broken at -32 C (-25 F) and with the slag stringers parallel to the fracture surface. As in 4282, the matrix fractured by cleavage. Note voids, such as at arrows, which were matrix-slag interfaces. Compare with fractographs 4284 and 4285, at right.

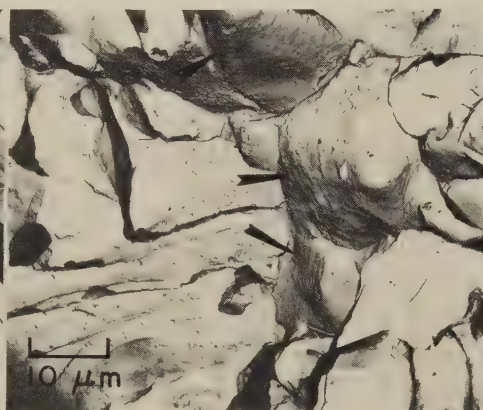
TEM fractograph (p-c replica) 1000×
4284 Surface of a Charpy impact fracture in a third specimen of the same wrought iron as in fractographs 4282 and 4283, but broken at 10 C (50 F). As in 4282, the slag stringers are normal to the fracture surface. Most of this surface formed by coalescence of voids, such as at arrows, which originally formed around slag particles. See also fractograph 4285, at right.

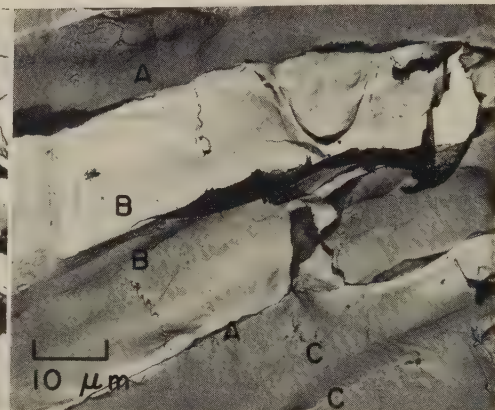
TEM fractograph (p-c replica) 1000×
4285 Charpy impact fracture in a fourth specimen of same wrought iron as in 4282, but broken at 149 C (300 F) and with the slag stringers parallel to the fracture surface. Most of this surface formed by coalescence of microvoids (such as the one at A-A) originally formed around slag particles. The matrix-slag prior interfaces (B-B and C-C) were only slightly deformed.

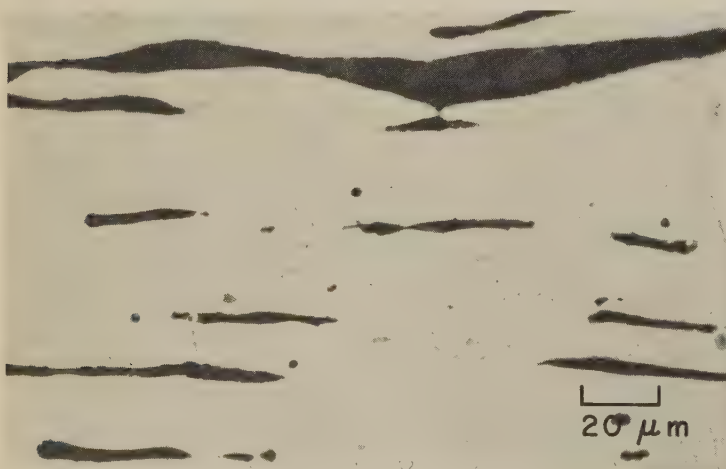
Light micrograph (as polished; not etched) 500×
4286 A polished longitudinal section through a specimen of wrought iron, showing the slag particles, which have been elongated in the direction of rolling. See also 4287, at right.

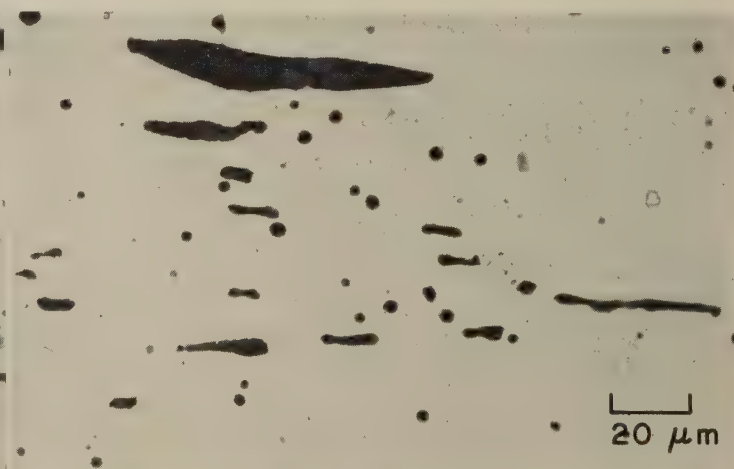
Light micrograph (as polished; not etched) 500×
4287 A polished section through a specimen of wrought iron, taken transverse to the rolling direction. Many slag stringers are round in cross section, but some are slablike.

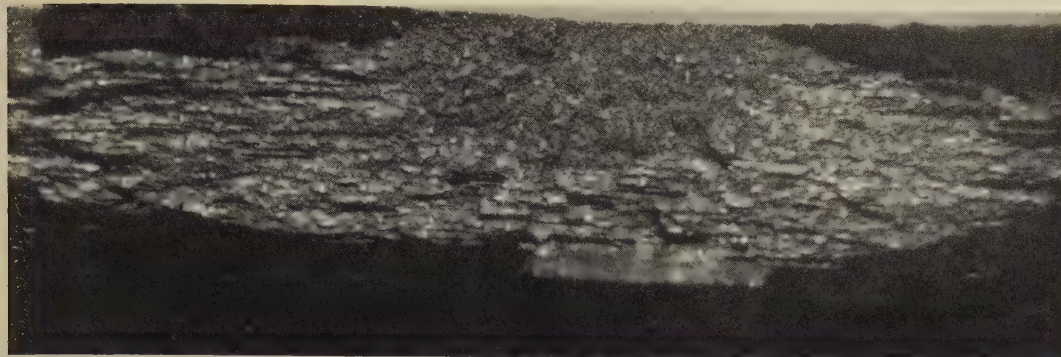
Light fractograph

4288 Fracture surface of a rocket-propellant case of $\frac{1}{16}$ -in.-thick 4130 steel with nominal yield strength of 1241 MPa (180 ksi). Fracture occurred after testing for $2\frac{1}{2}$ hr at 182 C (360 F) and internal gage pressure of 6.2 MPa (900 psi), or a hoop stress of about 448 MPa (65 ksi), and originated in a heat-affected zone of a fusion weld that attached a clip. Cracking started in a typical "thumbnail" area (at top center) and continued by flat fracture nearly through the thickness of the sheet; final fracture was of a nearly full shear type. See also 4289 to 4292.

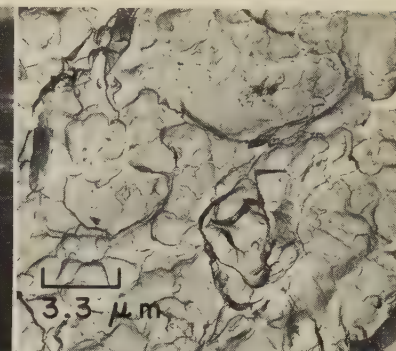
TEM fractograph (p-c replica) 3000X

4289 A TEM reproduction of a dull region in the crack-origin area of the fracture in 4288, showing equiaxed dimples, which were produced by tension overload. Compare with 4290.

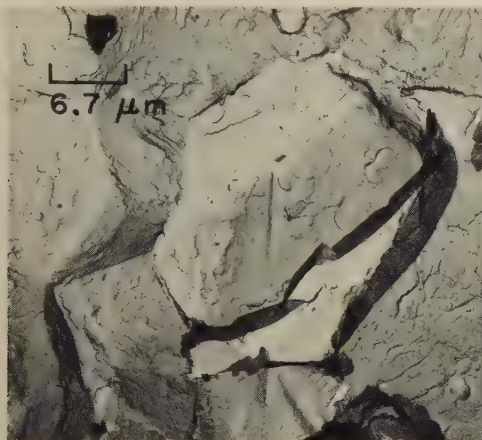
TEM fractograph (p-c replica)

4290 A TEM reproduction of a shiny-faceted region in the crack-origin area of the fracture in 4288. Here, the fracture was intergranular, which suggests the existence of hydrogen embrittlement.

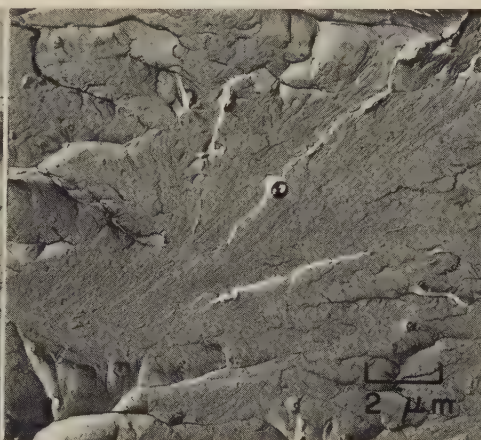
TEM fractograph (p-c replica)

4291 Shiny-faceted region in the crack-origin area of a fracture produced in the rocket case of 4288 by a sharp hammer blow at an adjacent fusion welded clip, showing cleavage facets. See also 4292.

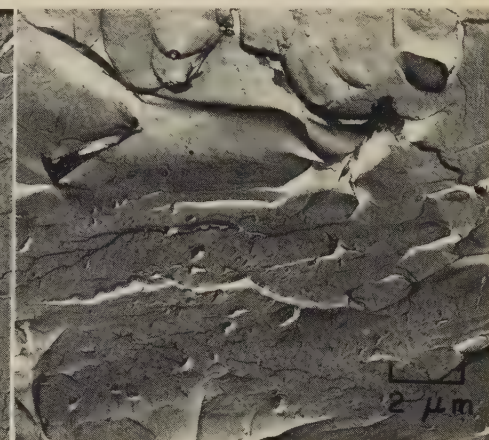
TEM fractograph (p-c replica)

4292 Another shiny-faceted region in the crack-origin area of the fracture in 4291, showing quasicleavage facets. Like 4291, this shows no intergranular separation, which would require sustained loading.

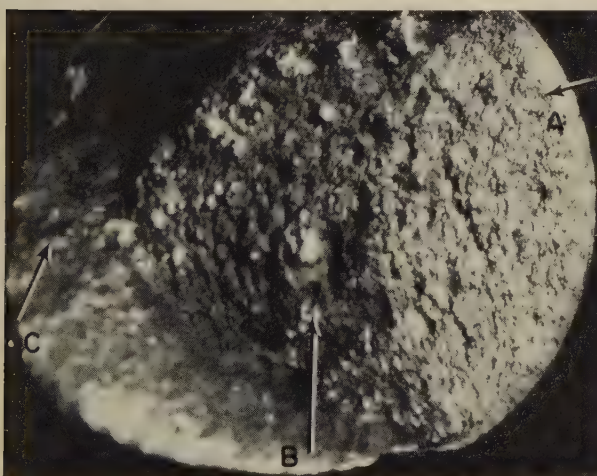
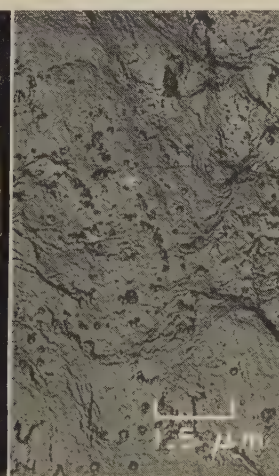
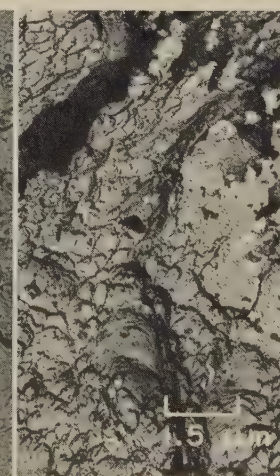
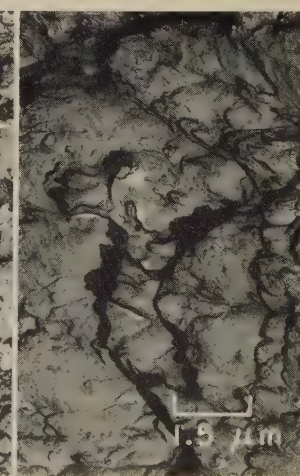
4293, 4294, 4295, 4296

Fractograph 4293 (far left) shows a fracture surface of a helicopter damper-actuator rod made of 4140 steel with tensile strength between 862 and 1000 MPa (125 and 145 ksi). Fracture began as a fatigue crack at A, probably of low-cycle nature, that extended through one-third of the cross section. The crack continued as a fast fracture, ending in the shear lip at left edge. Fractograph 4294 (second from left) is a TEM reproduction taken from zone A in 4293, showing poorly defined fatigue striations. In fractograph 4295 (third from left), which was taken from the fast-fracture area at B in 4293, equiaxed dimples are evident. Fractograph 4296 (far right), obtained from the shear-lip zone at C in 4293, shows the expected shear dimples.

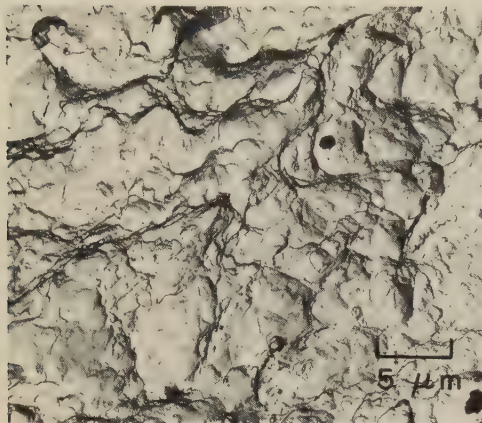
TEM fractograph (p-c replica) 2000×
4297 Surface of a tension-overload fracture in a notched specimen of AMS 6434 steel sheet that was broken at 27 C (81 F), showing small equiaxed dimples. The heavy curved lines are intersections of dimple surfaces. See 4298 and 4299.

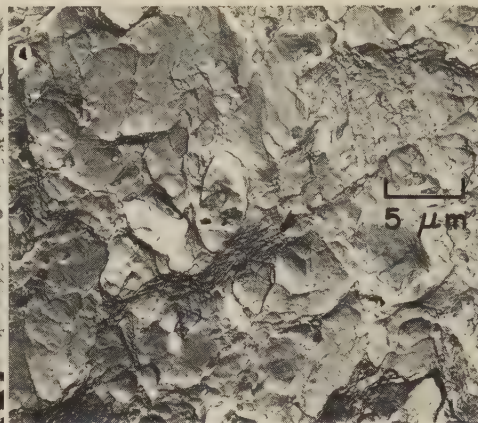
TEM fractograph (p-c replica) 2000×
4298 Surface of a tension-overload fracture in a notched specimen of the same AMS 6434 steel sheet as in 4297, but broken at -73 C (-99 F). The dimples here are of the same size and nature as those in 4297. See also fractograph 4299.

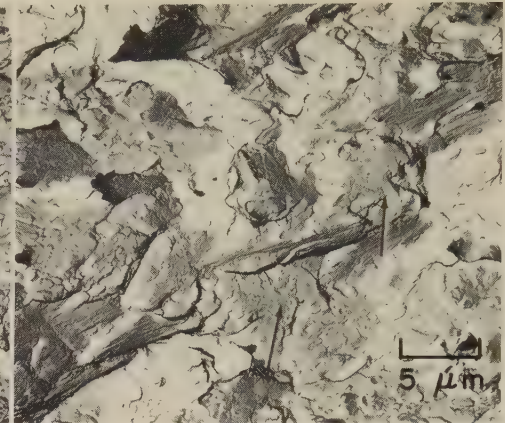
TEM fractograph (p-c replica) 2000×
4299 Surface of a tension-overload fracture in a notched specimen of the same AMS 6434 steel sheet as in fractographs 4297 and 4298, but broken at -190 C (-310 F), showing a mixture of scattered dimples and (at arrows) cleavage facets.

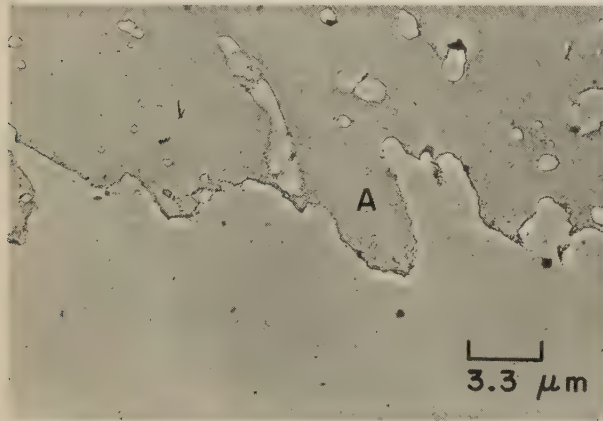
TEM micrograph (p-c replica; nital etch) 3000×
4300 A polished and etched section through an unnotched specimen of AMS 6434 steel broken by tension overload at room temperature, showing a profile of the fracture surface, which is protected by mounting material (at top). Note dimple in profile (A). See 4301.

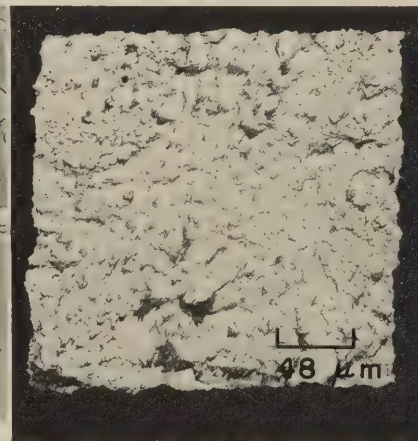
TEM fractograph (p-c replica) 210×
4301 TEM replica of an area of a shear lip in the fracture surface of the specimen of AMS 6434 steel in 4300, showing dimples.

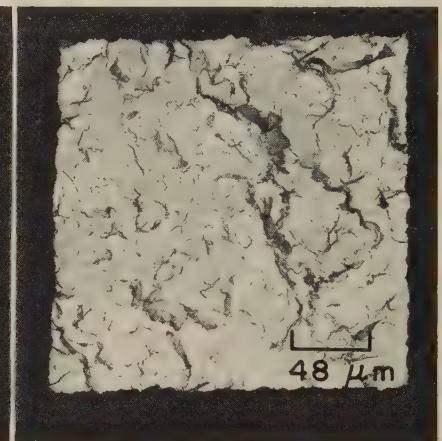
TEM fractograph (p-c replica) 210×
4302 Fracture surface of a specimen of the same AMS 6434 steel as in 4300, but broken at -196 C (-321 F), showing cleavage facets.

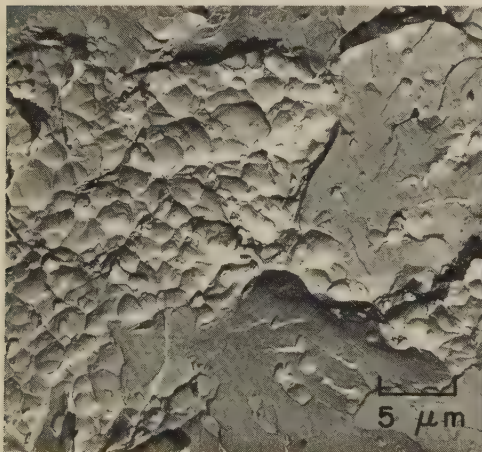
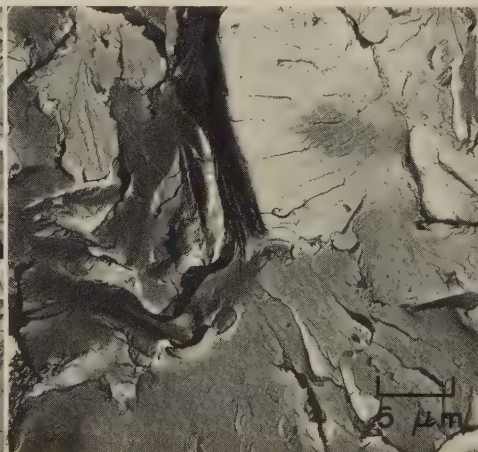
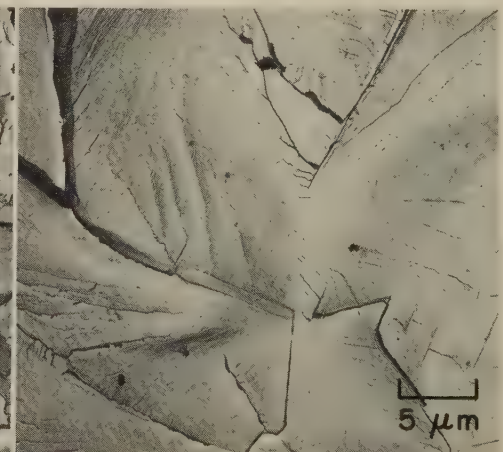
TEM fractograph (p-c replica) 2000×
4303, 4304, 4305

Surfaces of fractures in three pressure vessels made of AMS 6434 steel. Fractograph 4303 (left) shows equiaxed dimples, which resulted from tension overload, and quasicleavage facets. Fractograph 4304 (center) shows quasicleavage facets plus (at bottom left) a small region of dimples. Fractograph 4305 (right) shows cleavage facets in large ferrite grains; these facets contain many cleavage steps that originated at twist boundaries.

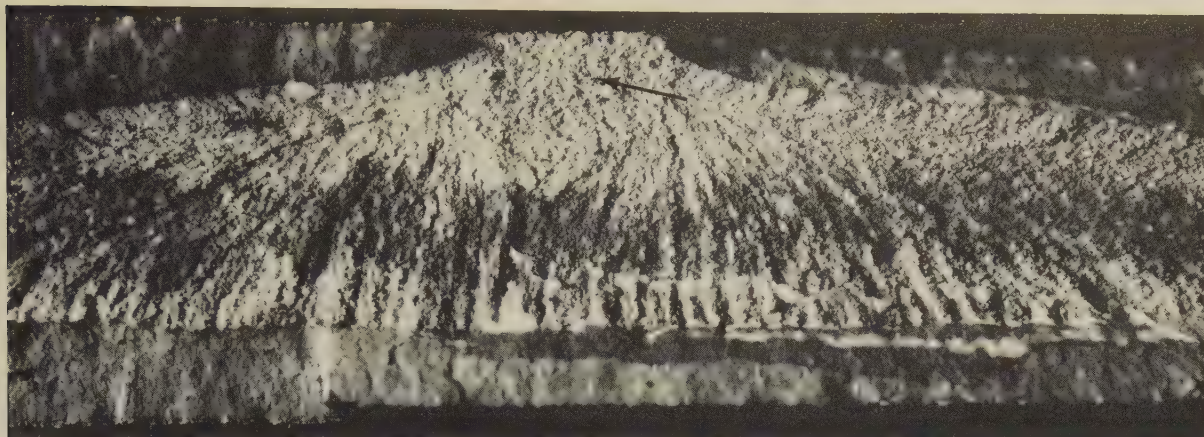
Light fractograph

4306 Surface of a fracture in a wall of a flask made of AMS 6434 steel tempered at 204 C (400 F) that was stressed while exposed to tap water, which produced stress-corrosion cracking. See TEM fractograph 4307 (below) for a higher-magnification view of the region at arrow.

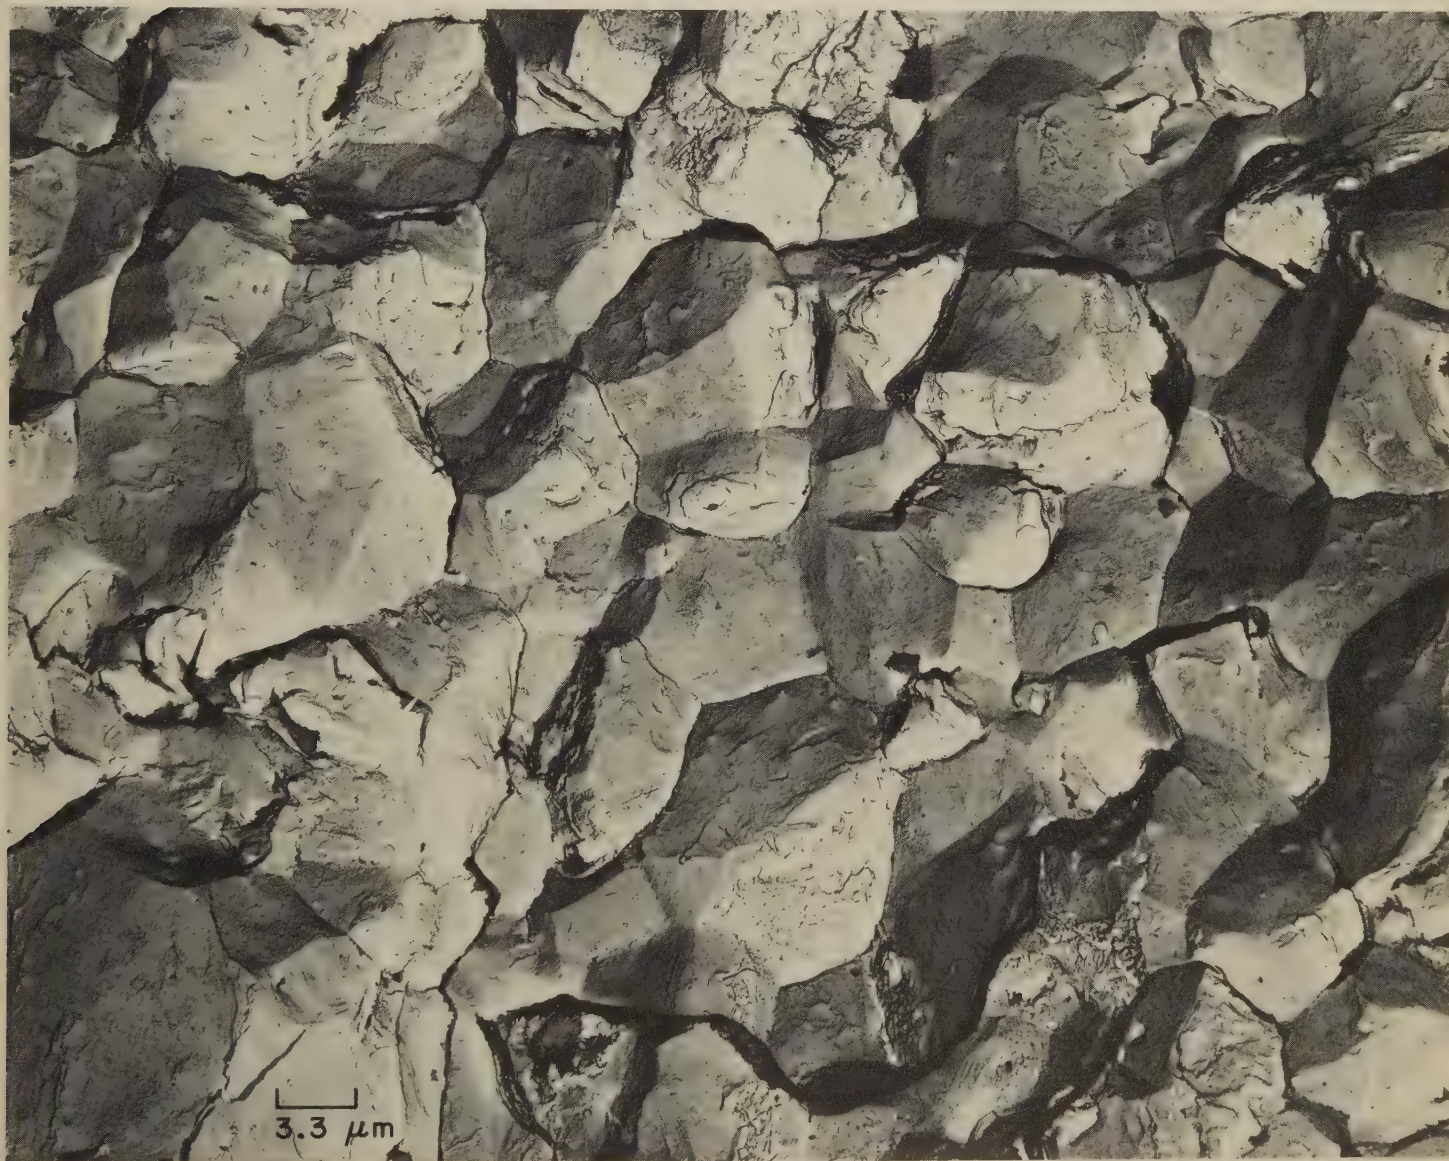
TEM fractograph (p-c replica)

4307 Higher-magnification view of fracture surface at arrow in 4306, showing clearly the intergranular nature of the fracture, which resulted from stress-corrosion cracking. Grains generally are equiaxed, and the fracture has closely followed grain boundaries.

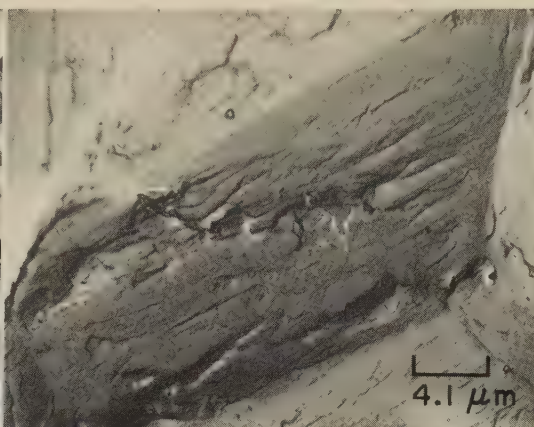
TEM fractograph (p-c replica)

4309 Surface of an intergranular fracture, which was caused by hydrogen-embrittlement cracking along grain boundaries, in a specimen of 4315 steel heat treated the same as the specimen in fractograph 4308 (left).

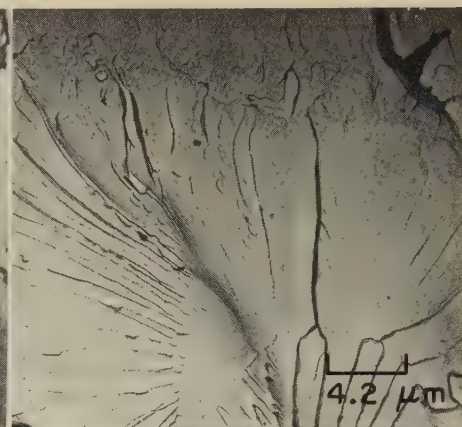
TEM fractograph (p-c replica)

4310 Surface of a transgranular cleavage fracture, caused by hydrogen embrittlement, in 4315 steel heat treated same as 4308. Note cleavage steps that originated at tilt boundaries.

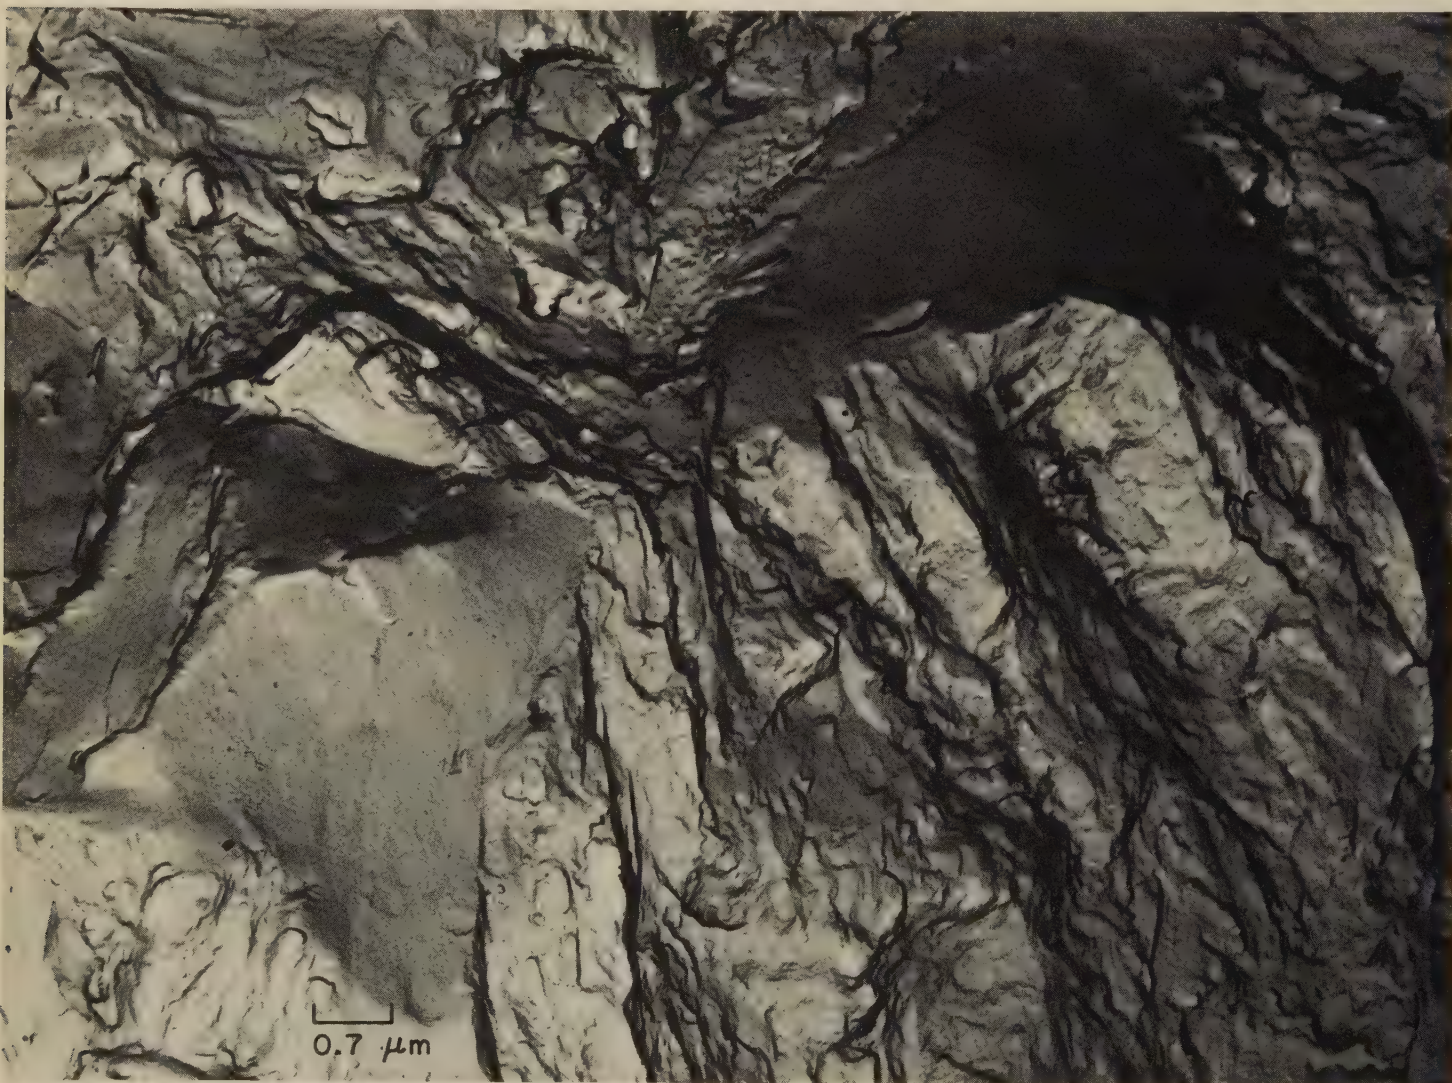
TEM fractograph (p-c replica)

4311 A highly magnified view of a fatigue-fracture surface in a specimen of 4340 steel. The specimen was austenitized and quenched, tempered at 204 C (400 F) and then fatigue tested in humid air. Facets at left and at upper right indicate that crack growth proceeded partly by intergranular separation; this implies the possible presence of hydrogen embrittlement or stress-corrosion cracking. No real fatigue striations are discernible.

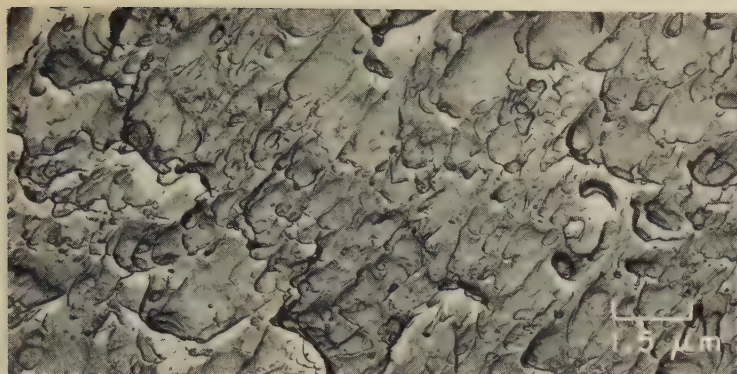
TEM fractograph (p-c replica)

4312 Surface of a fracture in an unnotched specimen of 4340 steel that was broken in tension overload, displaying elongated and quite flat shear dimples. Note that some crude steps have formed, which suggests that there may have been some degree of pulsation in the applied stress during testing.

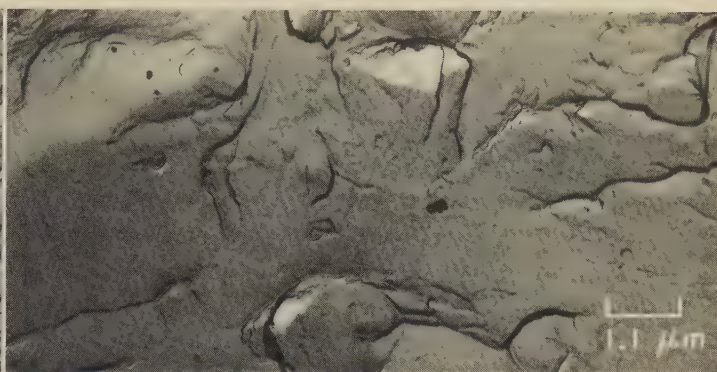
TEM fractograph (p-c replica)

4313 Surface of a fracture in a notched specimen of 4340 steel that was broken in tension overload, showing scattered dimples. It is not certain whether the remainder of the surface in this area consists of quasicleavage facets or of large dimples that have undergone appreciable stretching.

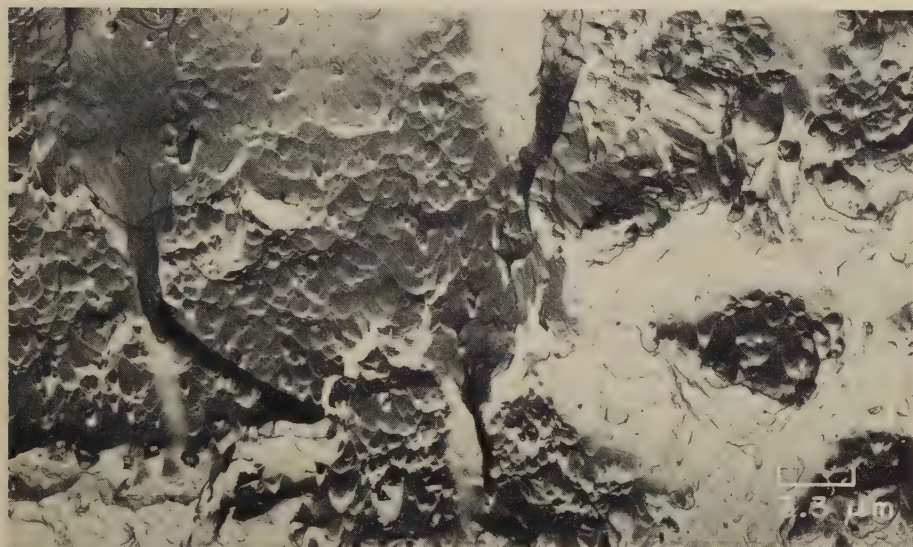
TEM fractograph (p-c replica)

4314 Surface of a fracture in a specimen of 4340 steel that was broken by impact at room temperature, showing small dimples of quite uniform size, some of which (at right) are equiaxed. At left are elongated tear dimples pointing toward a tear ridge (at bottom). At upper left are regions in which considerable local stretching has occurred. Some secondary cracking may be present.

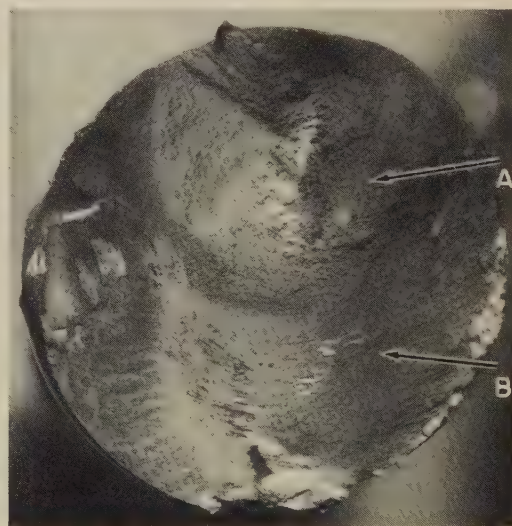
Light fractograph

4315 Torsion-overload fracture in 4340 steel oil quenched from 843 C (1550 F) and tempered at 635 C (1175 F) to a tensile strength of 931 MPa (135 ksi). In general, the fracture surface is flat and shiny. See 4316 and 4317 for TEM views of areas A and B.

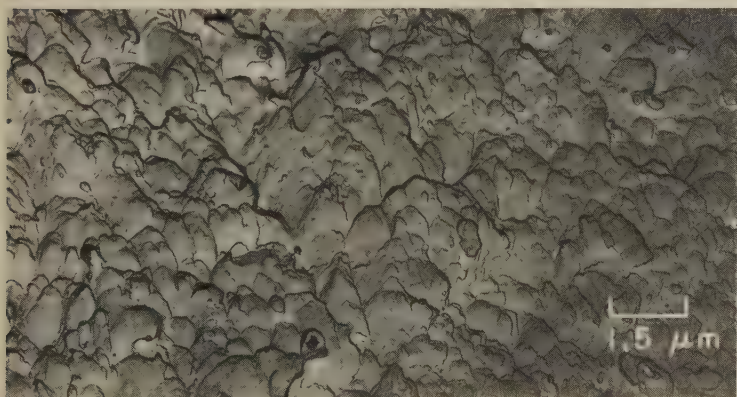
TEM fractograph (p-c replica)

4316 TEM replica of an area near letter A (in region of final rupture) in the torsion fracture in fractograph 4315 (above, at right), showing dimples, some of which are slightly elongated but many of which are essentially equiaxed.

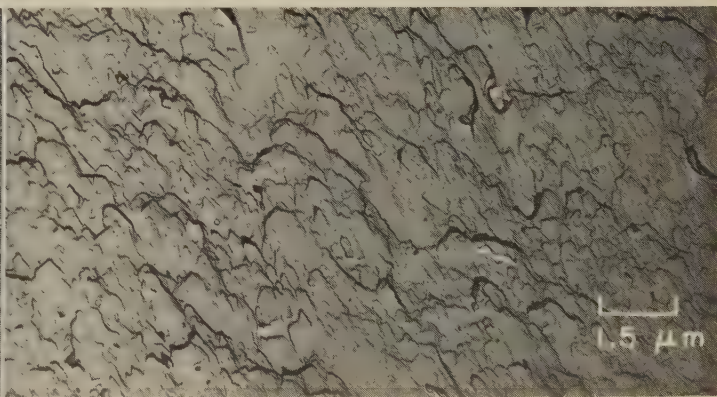
TEM fractograph (p-c replica)

4317 TEM replica of an area near letter B in 4315. The flat and noticeably elongated shear dimples present here are to be expected in this region, which in 4315 (at lower magnification) shows an appreciable amount of torsional deformation.

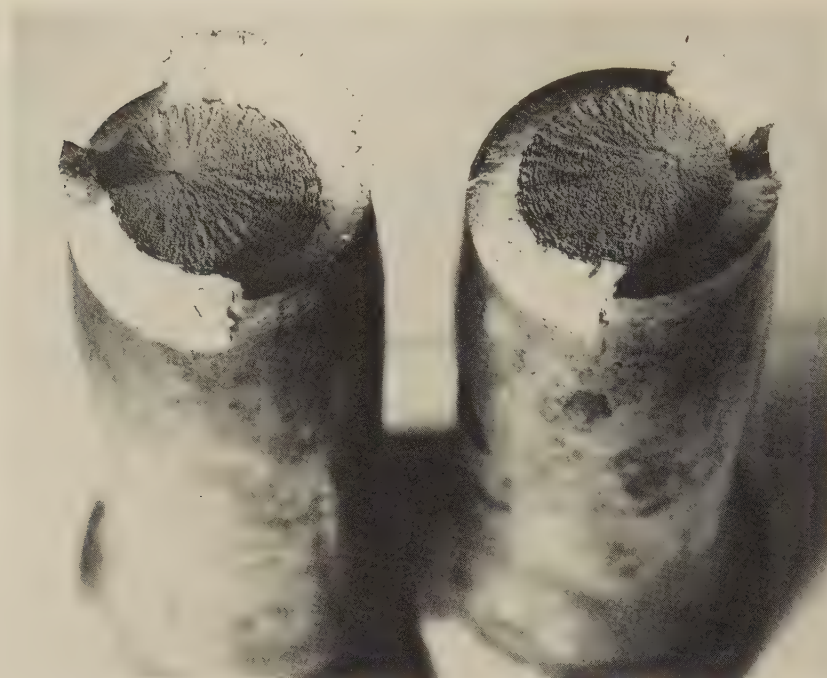
Light fractograph

4318 Matching surfaces of a cup-and-cone fracture in an unnotched tensile specimen of 4340 steel. Before being machined, the specimen had been heat treated to a tensile strength of 1944 MPa (282 ksi). It is evident that rupture originated at a small (but deep) pinhole, which is visible in each fracture surface. A small fibrous area with a zone of radial marks extending from it surrounds the pinhole. See also fractograph 4319 (below).

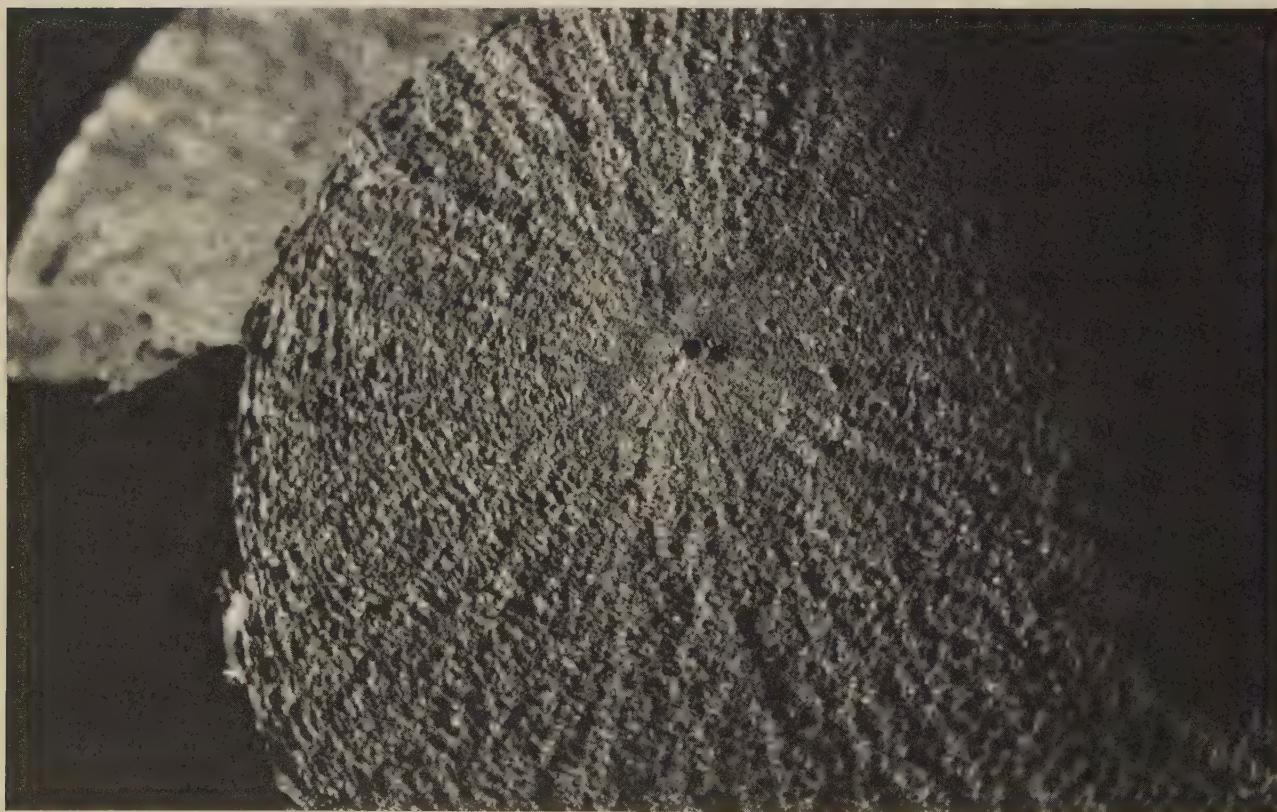
Light fractograph

4319 A more highly magnified view of the fracture-origin area in one of the fracture surfaces in 4318 (above). The pinhole at the crack nucleus is clearly visible just above center. At this magnification it is evident that the region surrounded by the shear lip exhibits characteristics of both fibrous and radial zones (circumferential marks and radial marks). The details of the surface within this area are shown in fractograph 4320 (facing page).

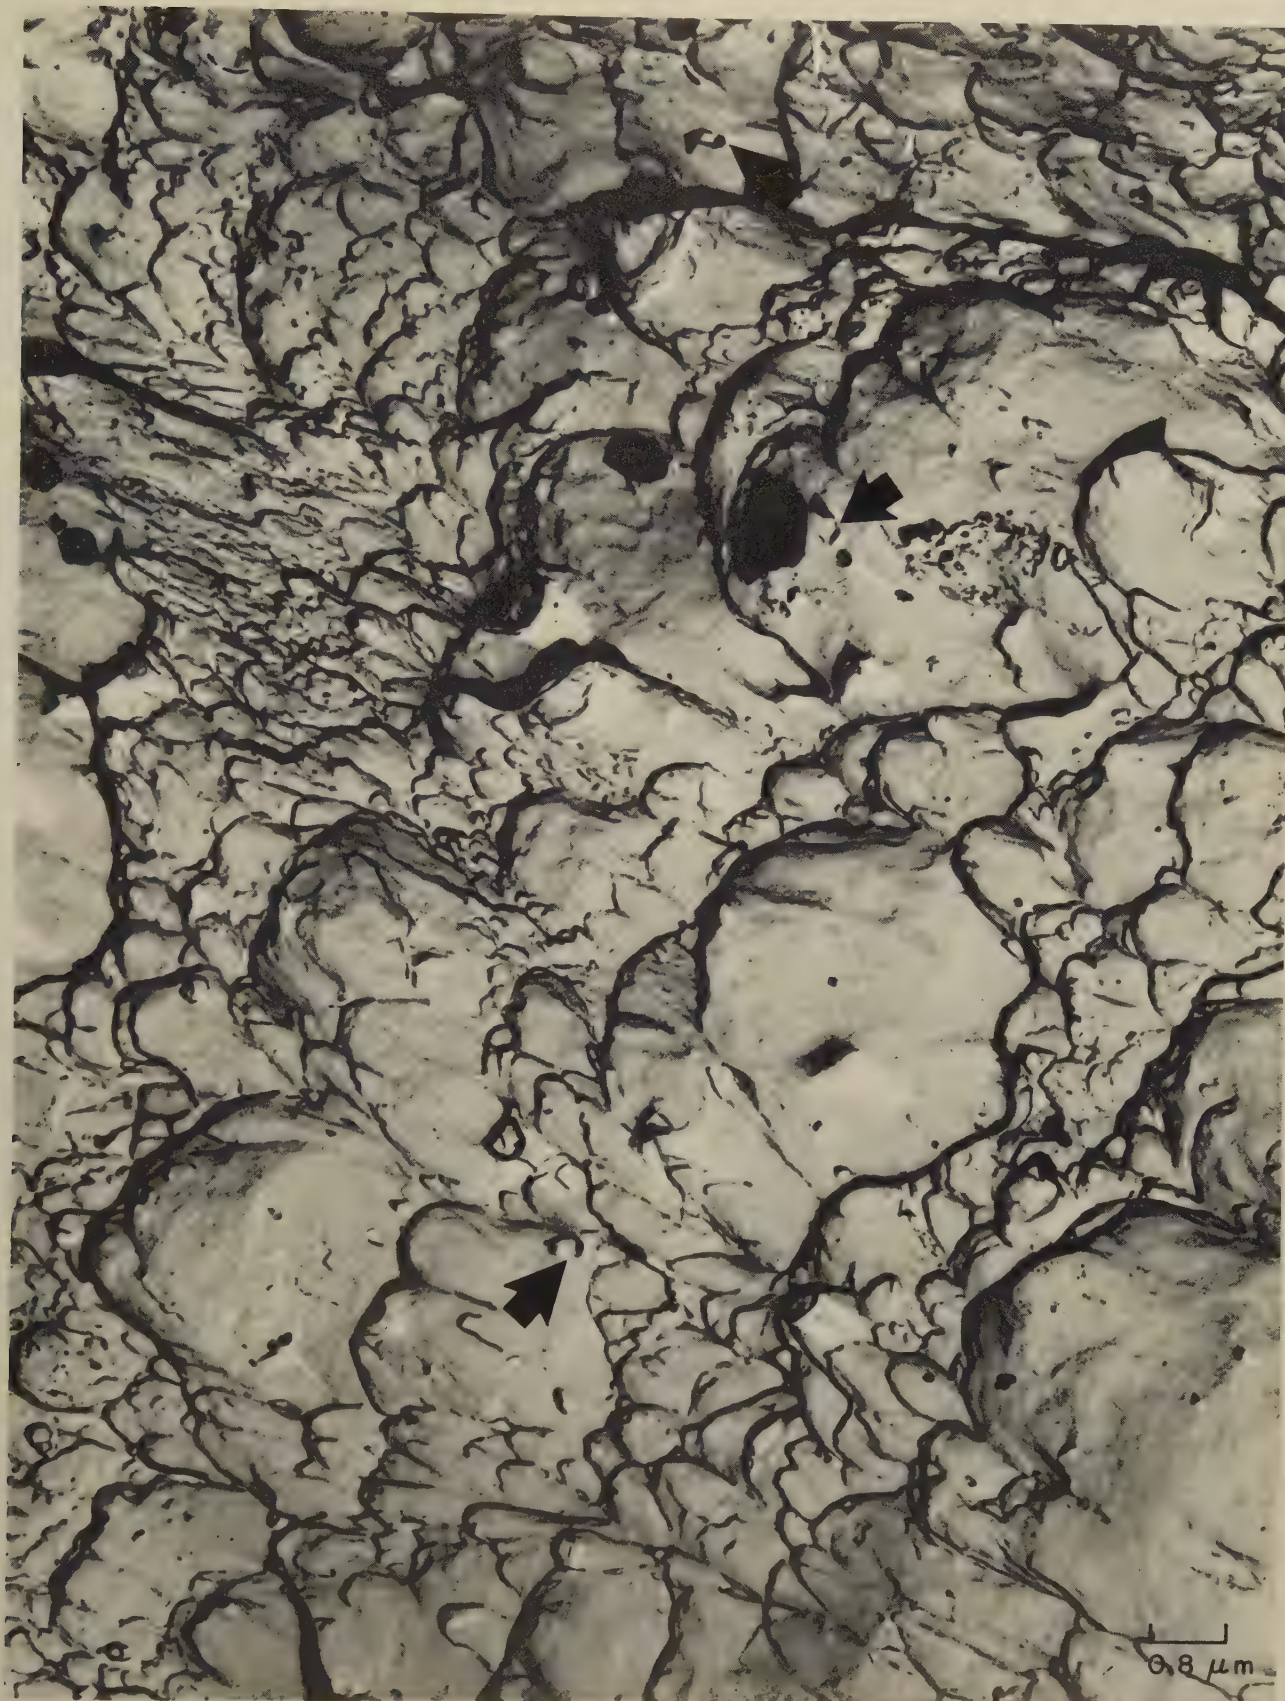
TEM fractograph (palladium-shadowed two-stage carbon replica)

4320 A TEM replica of the fracture surface of the 4340 steel tensile specimen in 4318 and 4319 (facing page), showing a region close to the pinhole that nucleated the crack. This region consists mainly of tear dimples of various sizes, formed during early stages of internal rupture. Also visible are small oval tear dimples (indicated by the arrows), each of which was formed at a point where a small subsurface void intersected the surface of an already existing dimple.
